# Town of Southern Shores

**DRAFT: TOWN OF SOUTHERN SHORES NORTH CAROLINA  
2019 BEACH ASSESSMENT REPORT**

**APTIM COASTAL PLANNING & ENGINEERING OF NORTH CAROLINA, INC.**

**September 2019**

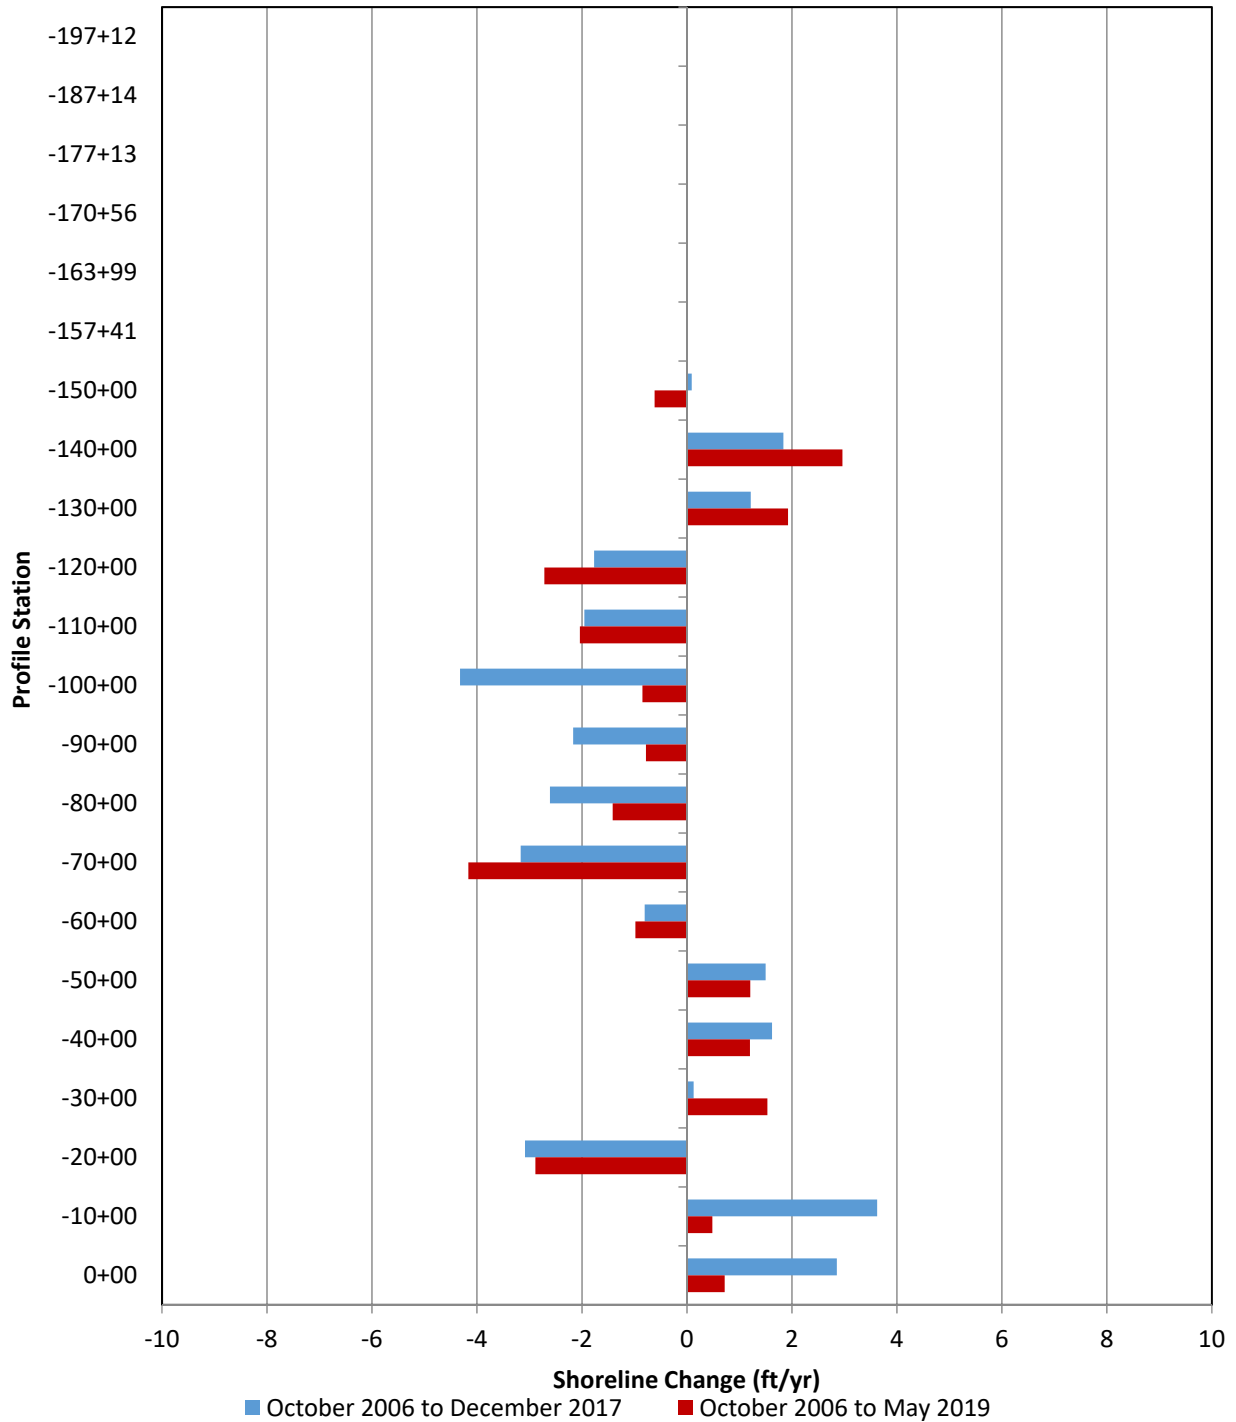
Figure 4. Shoreline change rates measured between October 2006 and December 2017, and October 2006 and May 2019.

MHW (+1.2 ft, NAVD88) Change Rate

A profile by profile comparison shows relatively minimal variation throughout the area over the 12.6-year period with rates ranging from -4.2 ft./yr. at Station -70+00 (approximately 500 ft. south of where Ocean Blvd. and Duck Rd. meet) to +3.0 ft./yr. at Station -140+00 (approximately 200 ft. south of 1<sup>st</sup> Ave).

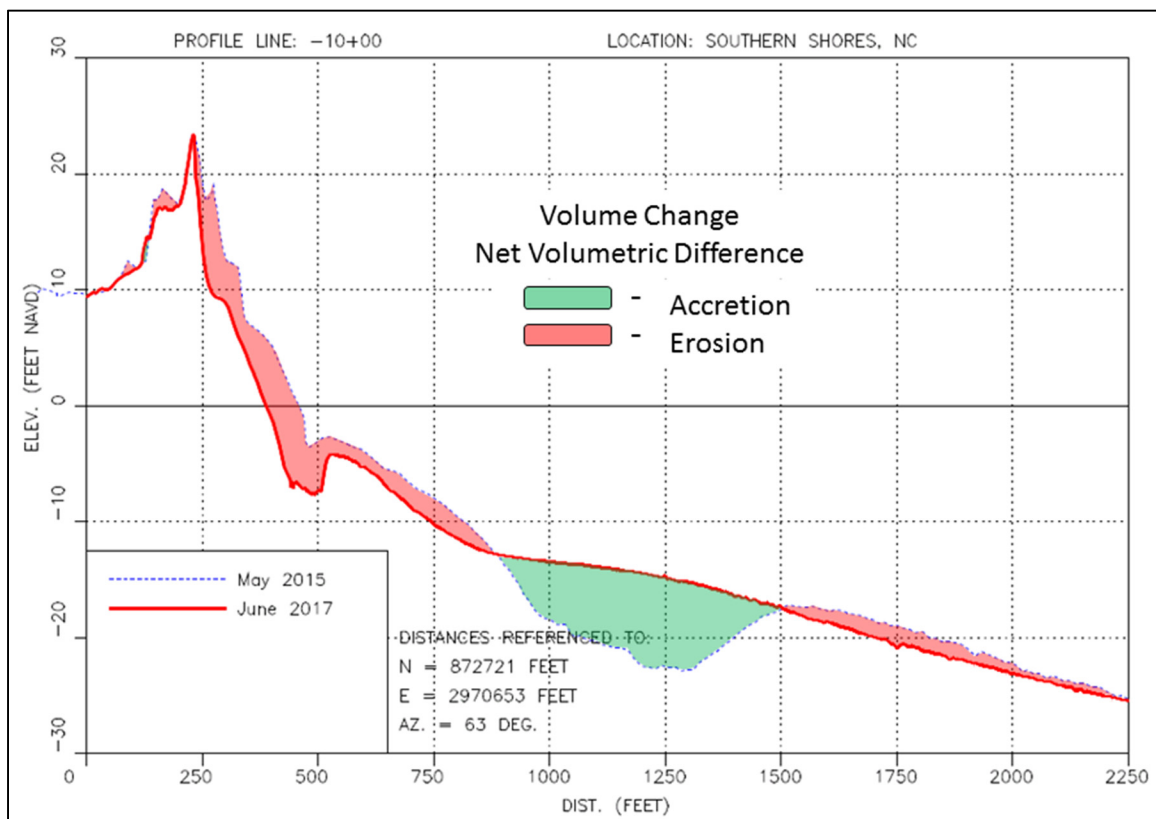
**Figure 6. Beach profile cross section illustrating volume change.**

Sand on the beach is distributed by wind and wave action over the entire active profile (from the dunes/vegetation out to the depth of closure). The dry beach often observed above the water represents only a fraction of the active beach profile. Therefore, the volume of sand measured on the entire profile is an important parameter to track in an effort to gauge the sediment budget, the health of the beach, and the performance of nourishment projects. The volume of sand in place is the metric that defines the three-dimensional beach, which provides storm protection. Figure 6 displays the same two profiles shown in Figure 3 with areas between the profiles color-coded to show volumetric gains (green-accretion) and volumetric losses (red-erosion) along the profile. The net difference between these volumetric gains and losses is referred to as volumetric change.

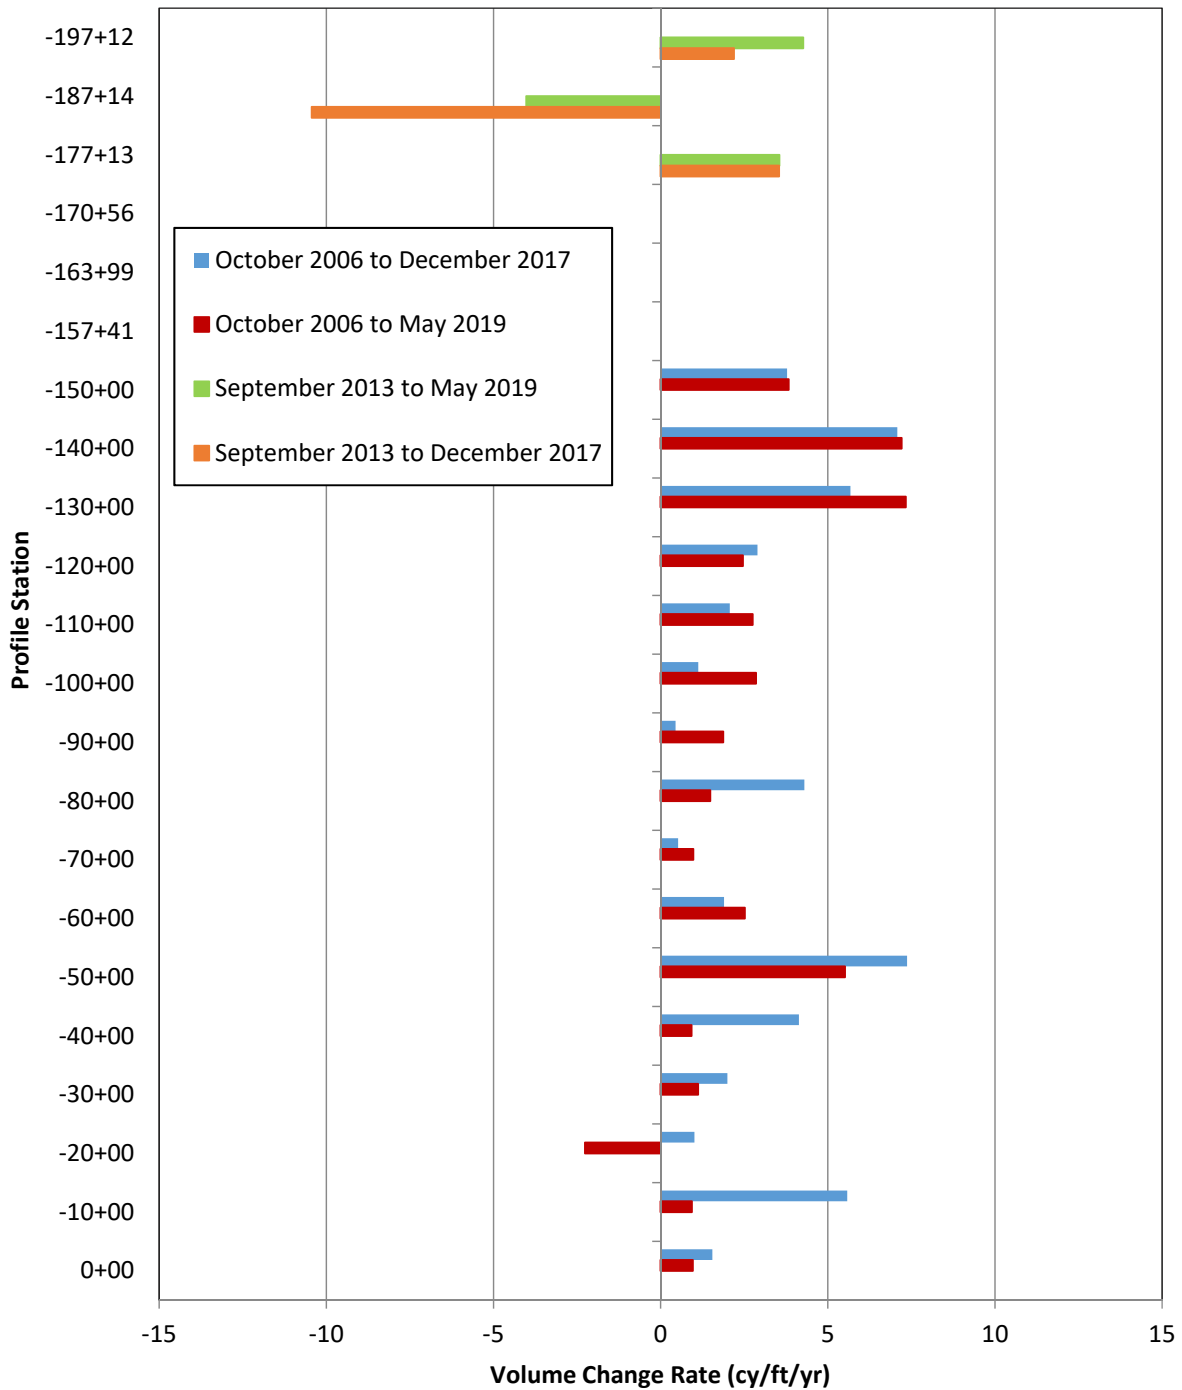
Figure 8. Long-Term Annual Volumetric Change Rate above -24 FT NAVD88 (CY/FT/YR)

Volumetric Change Rate Above -24.0 ft, NAVD88

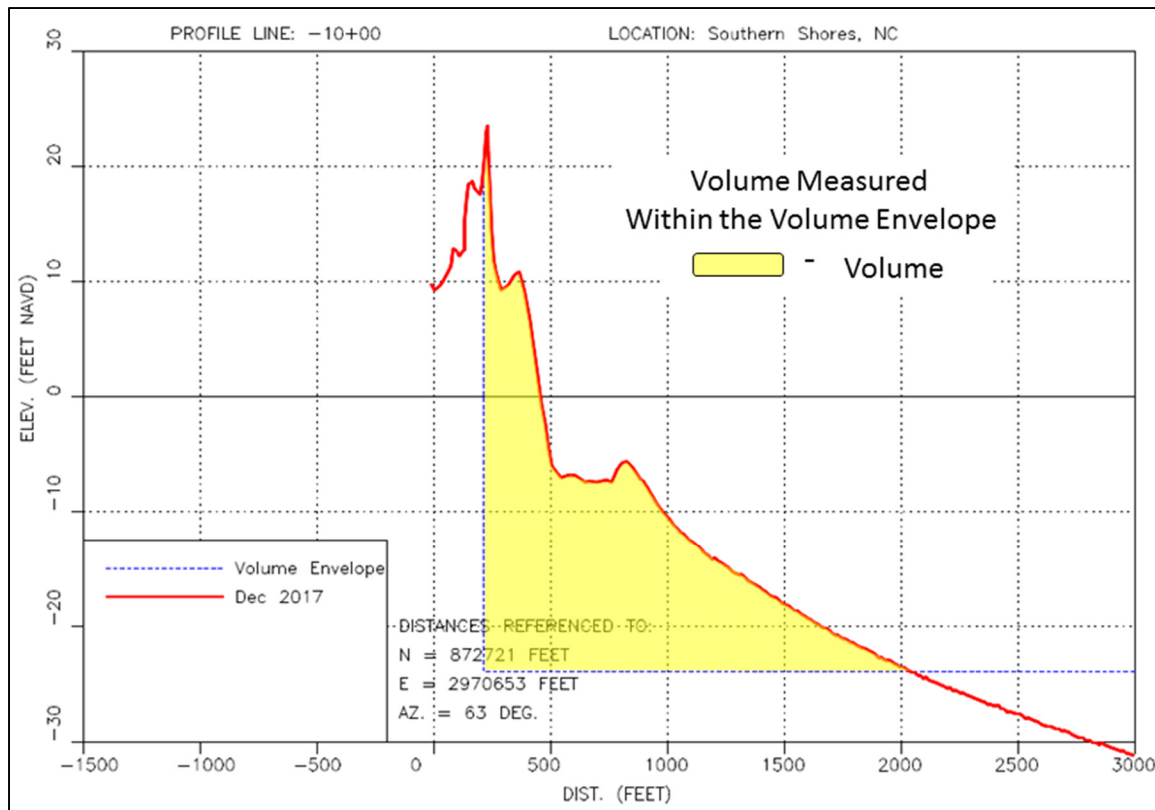
**Figure 9. Beach profile cross section illustrating the volume envelope.**

The total volume measured along each profile above the -24 ft. NAVD88 contour and seaward of the +20 ft. NAVD88 contour on the landward side of the dune, was calculated at each profile surveyed. This area of the profile is referred to in this report as the volume envelope. Figure 9 shows a cross section of profile -10+00, which graphically depicts the volume envelope. Comparing the volume measured in the volume envelope along the Town's oceanfront allows for the relative comparison of each profile and was used extensively in the development of the beach fill options included in the Beach Management Plan.

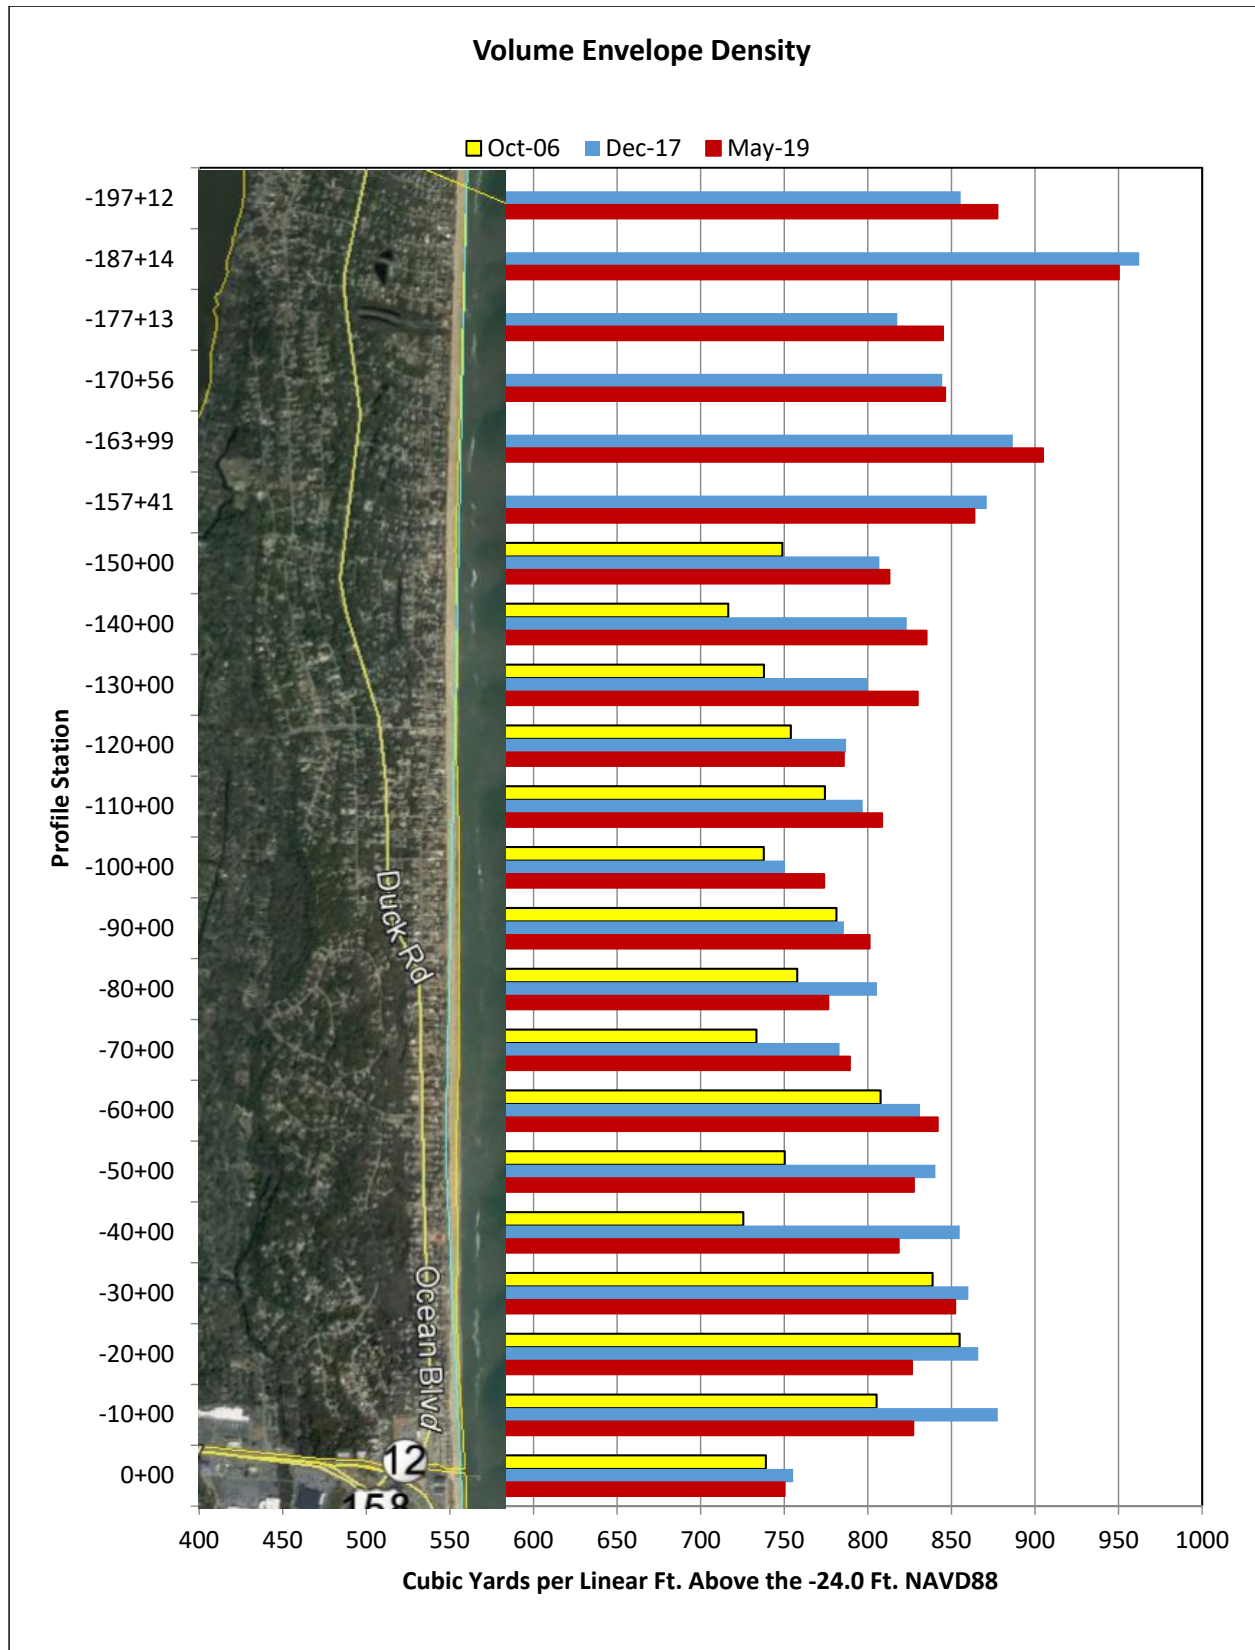
**Figure 10. Volume envelope calculations across all Southern Shores profiles.**

Figure 10 shows the volume measured within the volume envelope along each of the 22 Southern Shores profiles surveyed in December 2017 and May 2019. The average volume within the envelope measured along all 22 profiles in December 2017 was 830 cy/ft. and in May 2019 was 829 cy/lf. The volume envelope density is discussed in the subsequent sections in regards to evaluating the project extent and project volume.
