# Town of Southern Shores

COUNCIL MEETING-5:30 P.M.-PITTS CENTER

BEACH ASSESSMENT  
TOWN OF SOUTHERN SHORES, NC

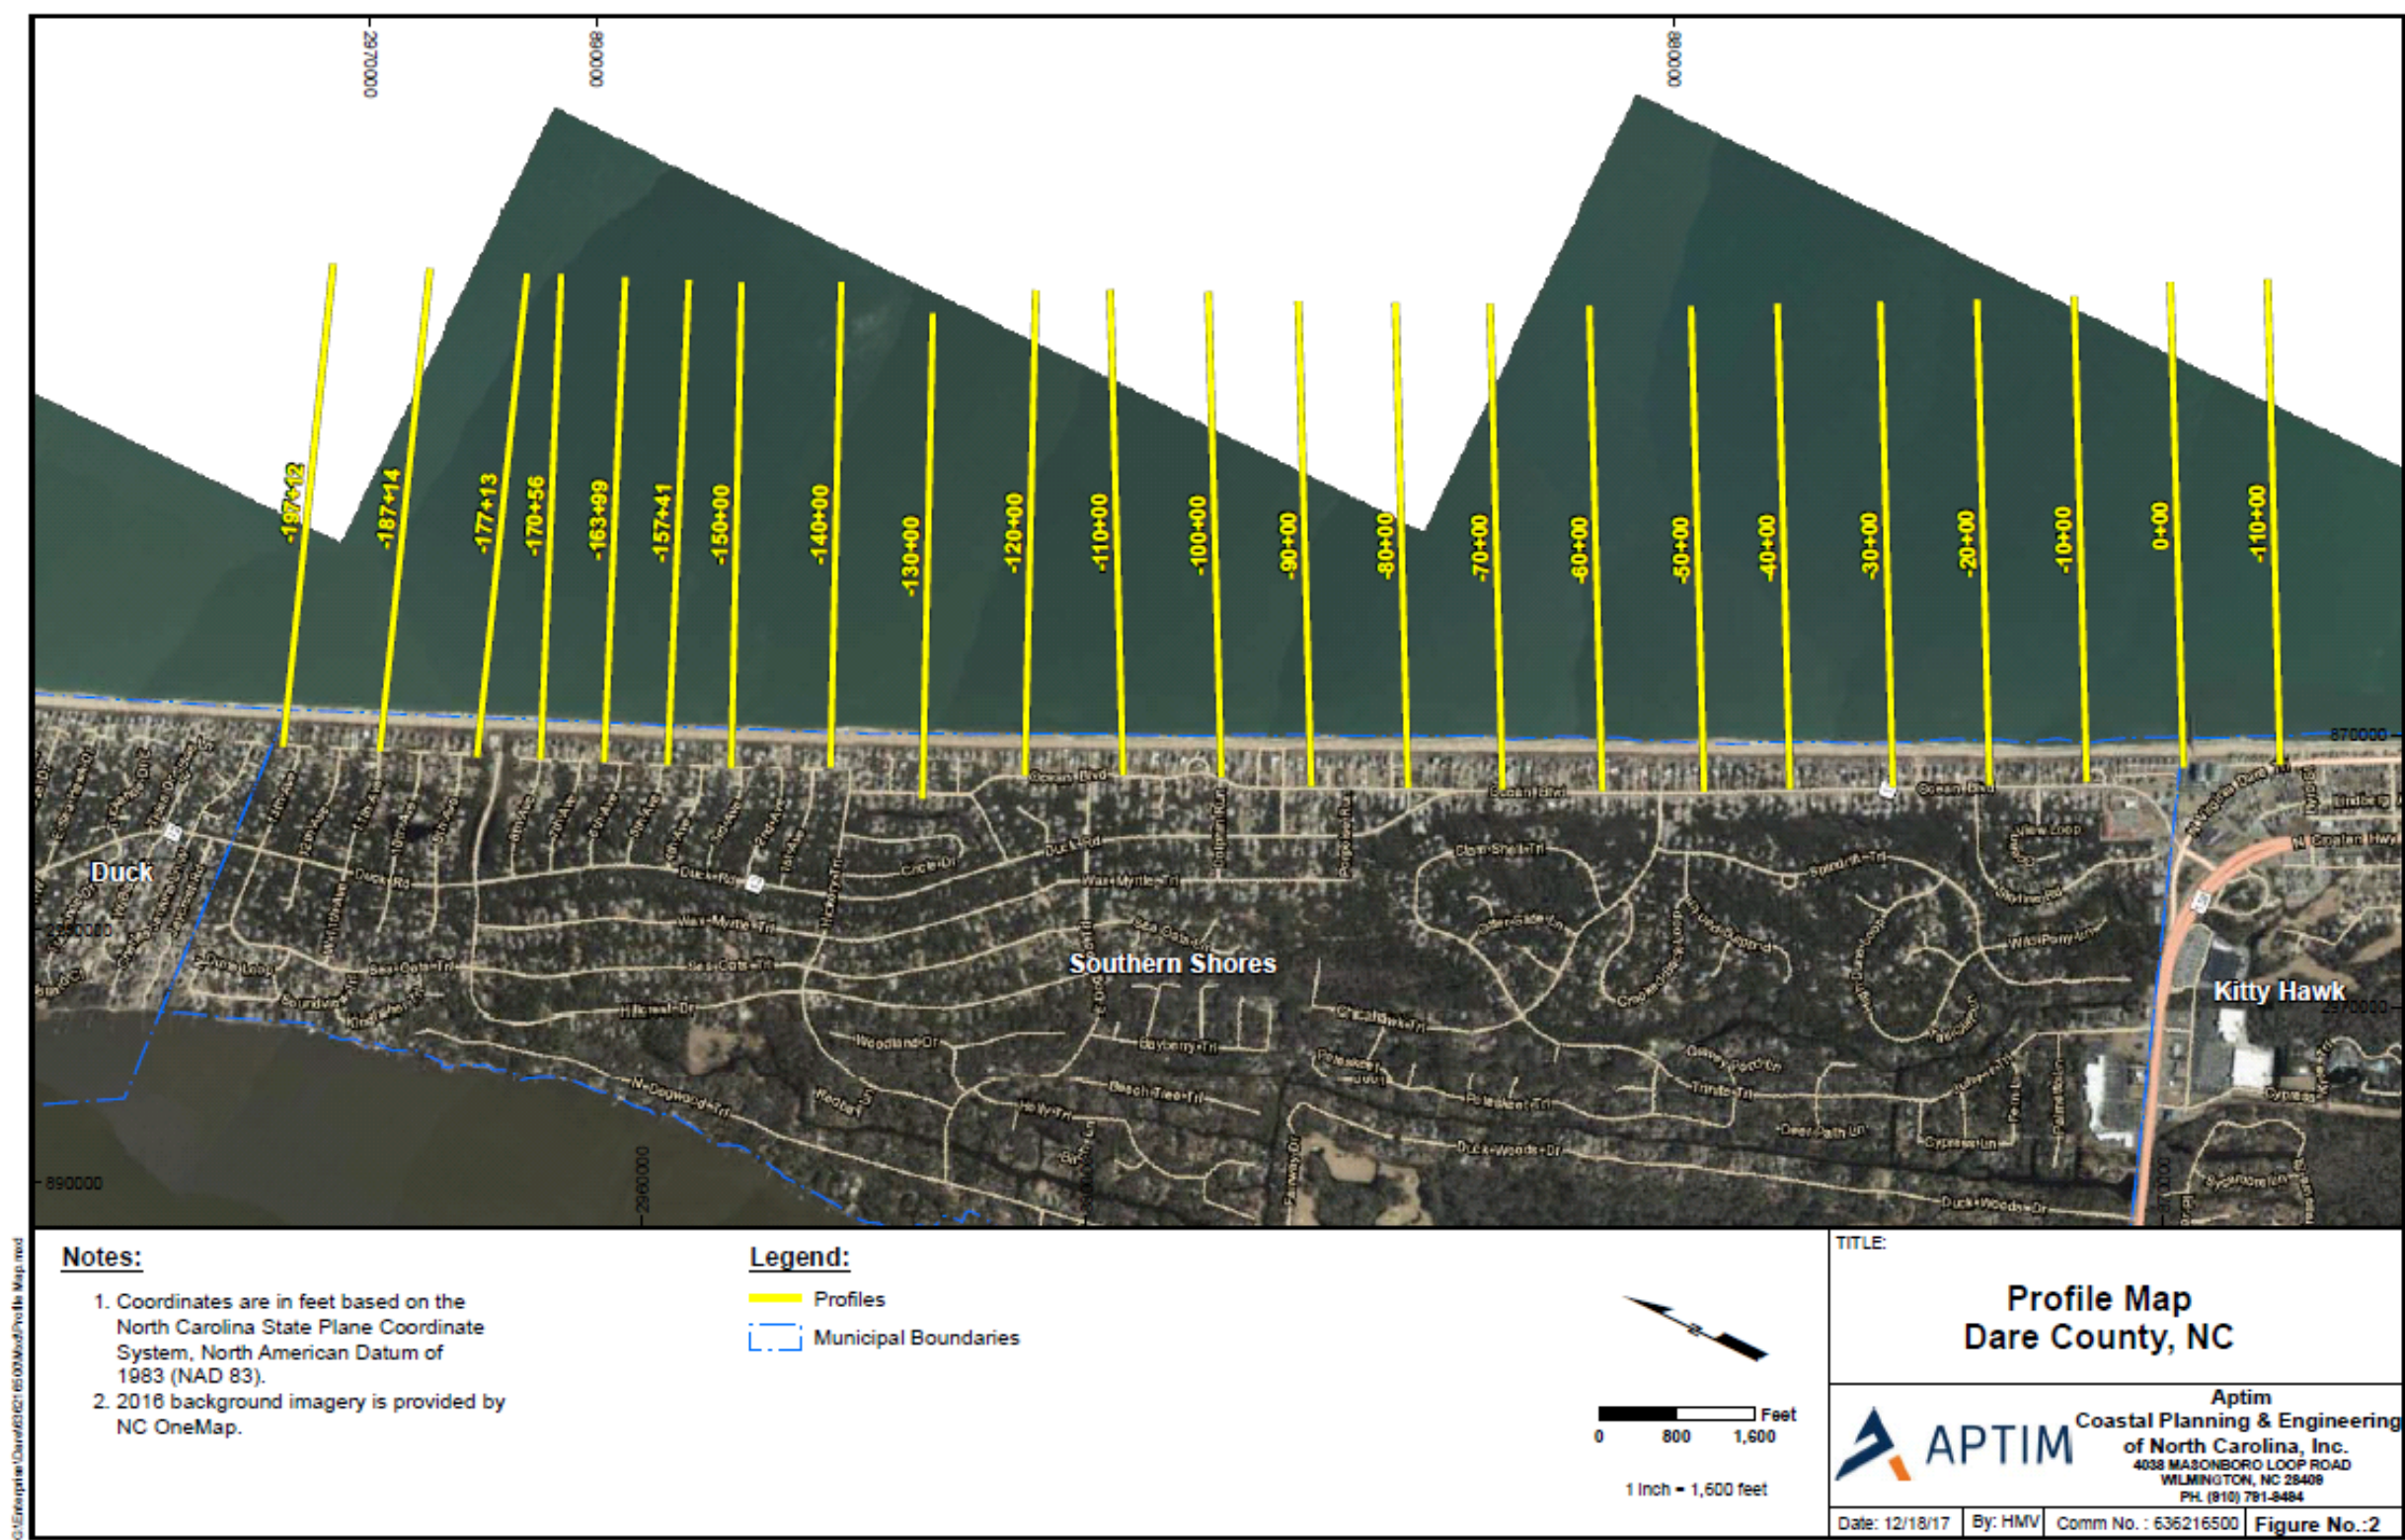
Figure 2. Map showing the location of the beach profiles along the Town of Southern Shores.

The beach profile surveys conducted by APTIM in May 2019 represent the second Town-wide beach profile survey and were compared to the December 2017 baseline survey for monitoring and analysis. Both the December 2017 and May 2019 surveys consist of a total of 22 profiles with a spacing of roughly 1,000 feet (Stations -197+12 to 0+00). Coordinates and azimuth of these profiles are provided in Table 1. Coordinates shown in Table 1 are referenced to the North Carolina State Plane coordinate system in feet NAD83 and the profile azimuth refers to degrees referenced to true north. Transects listed in Table 1 are shown graphically in Figure 2. The complete survey report, which includes detailed plan view maps and comparative profile cross sections, is included as Appendix A.

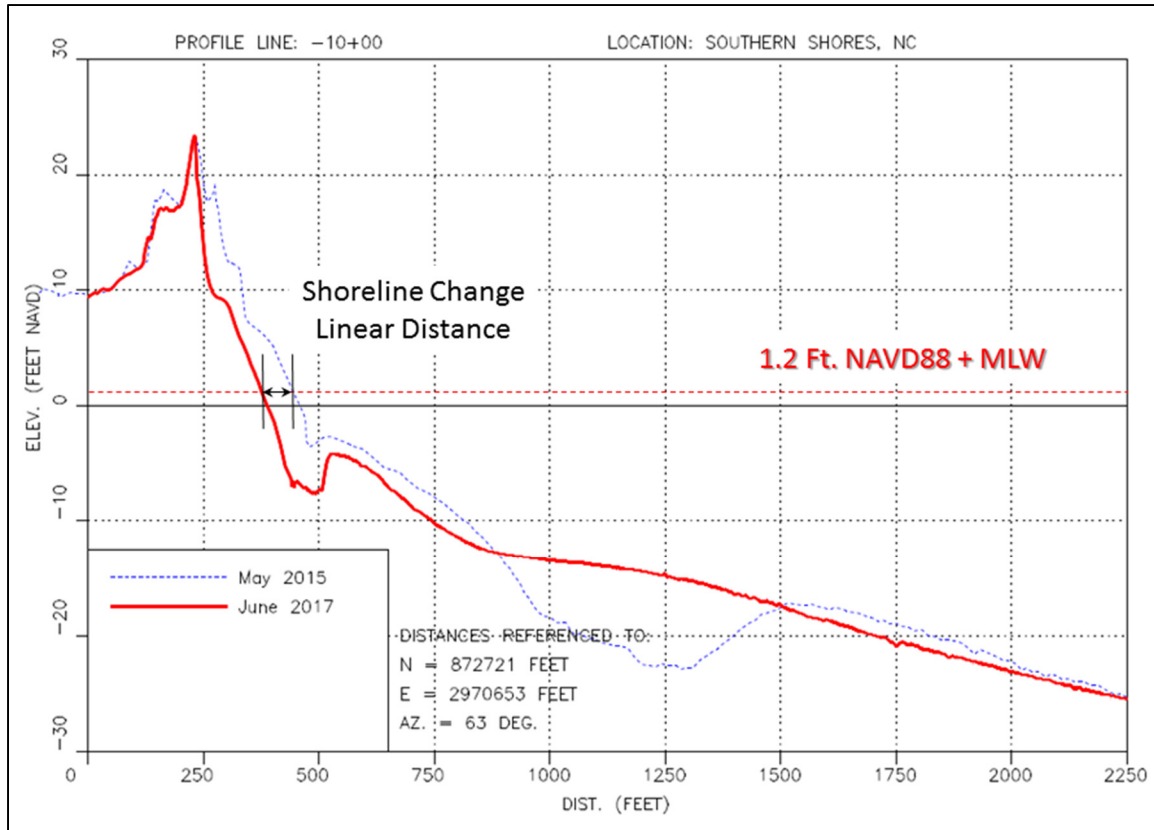
**Figure 3. Beach profile cross section illustrating shoreline change.**

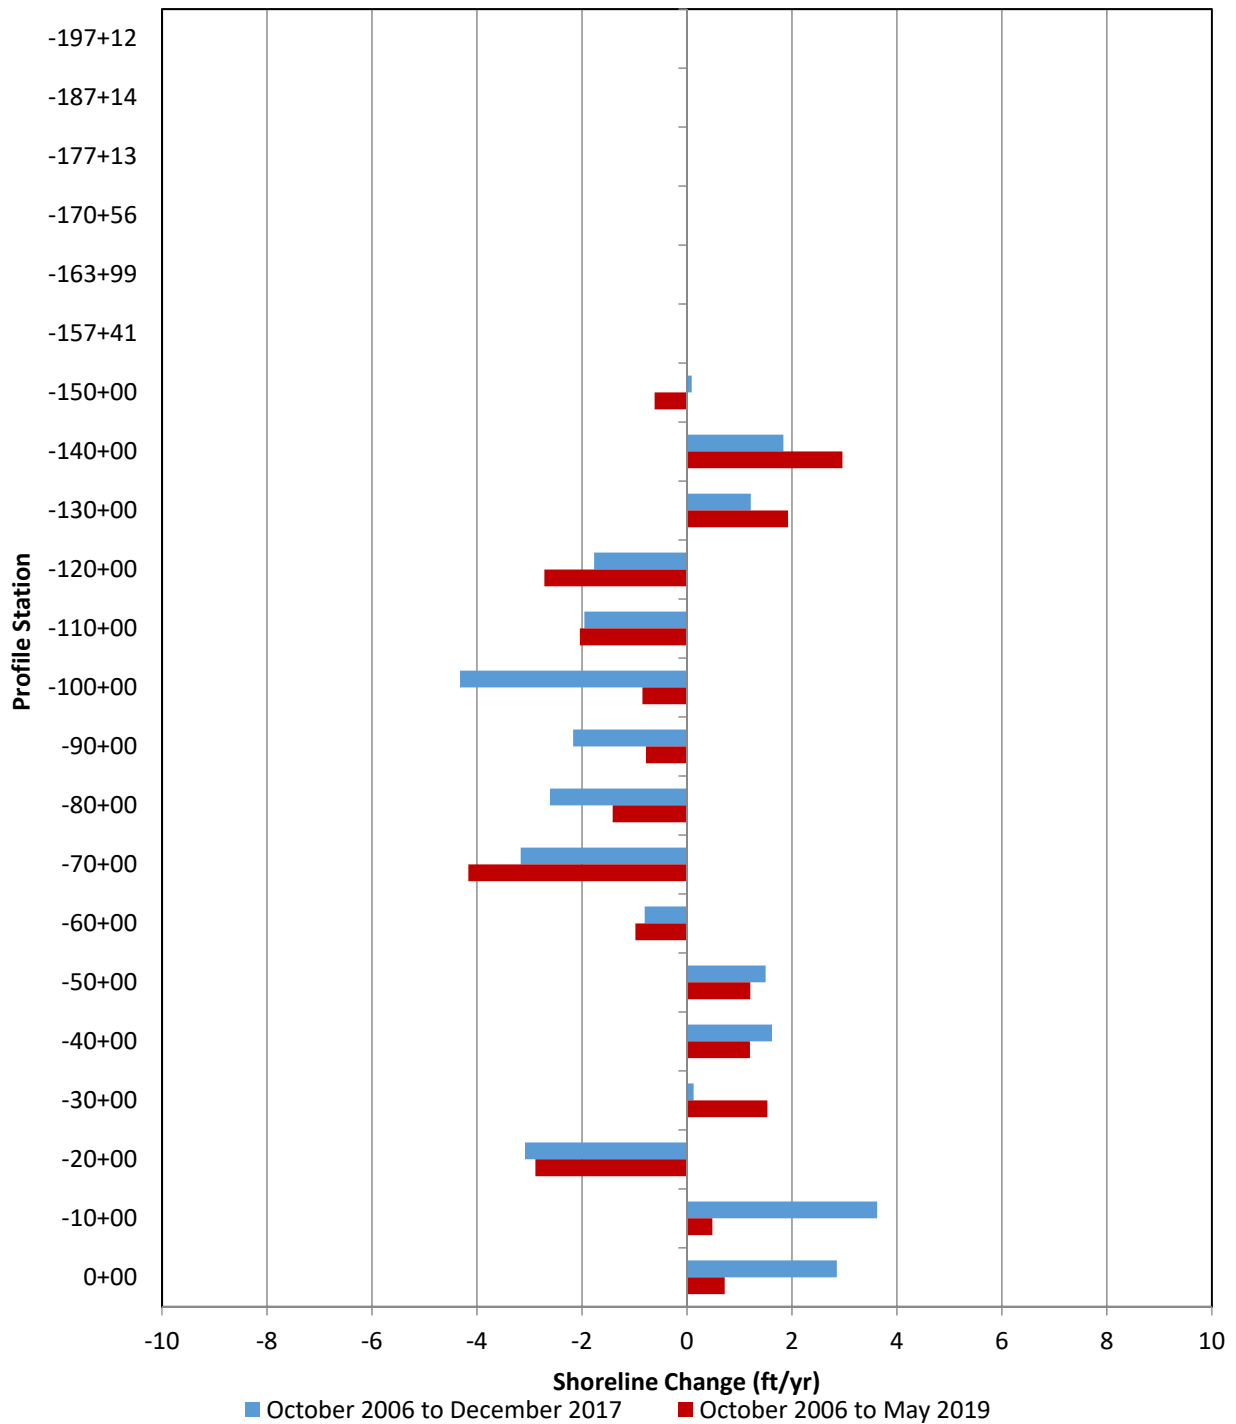
MHW (+1.2 ft, NAVD88) Change Rate

Figure 4. Shoreline change rates measured between October 2006 and December 2017, and October 2006 and May 2019.

The position of the MHW shoreline measured in May 2019 along the portion of beach between 3<sup>rd</sup> Ave. (Station -150+00) and the southern Town boundary (Station 0+00), was compared to the position of the MHW shoreline at the time of the September 2006 survey. An average MHW shoreline change of -5.0 ft. was measured over the approximately 12.6-year period. This equates to an average MHW shoreline change rate of -0.4 ft./yr. This is essentially the same average rate calculated for this section of beach between September 2006 and December 2017 (APTIM, 2018A). A comparison of the long-term MHW shoreline change rates measured as of December 2017 and May 2019 is provided in Figure 4.

A profile by profile comparison shows relatively minimal variation throughout the area over the 12.6-year period with rates ranging from -4.2 ft./yr. at Station -70+00 (approximately 500 ft. south of where Ocean Blvd. and Duck Rd. meet) to +3.0 ft./yr. at Station -140+00 (approximately 200 ft. south of 1<sup>st</sup> Ave).

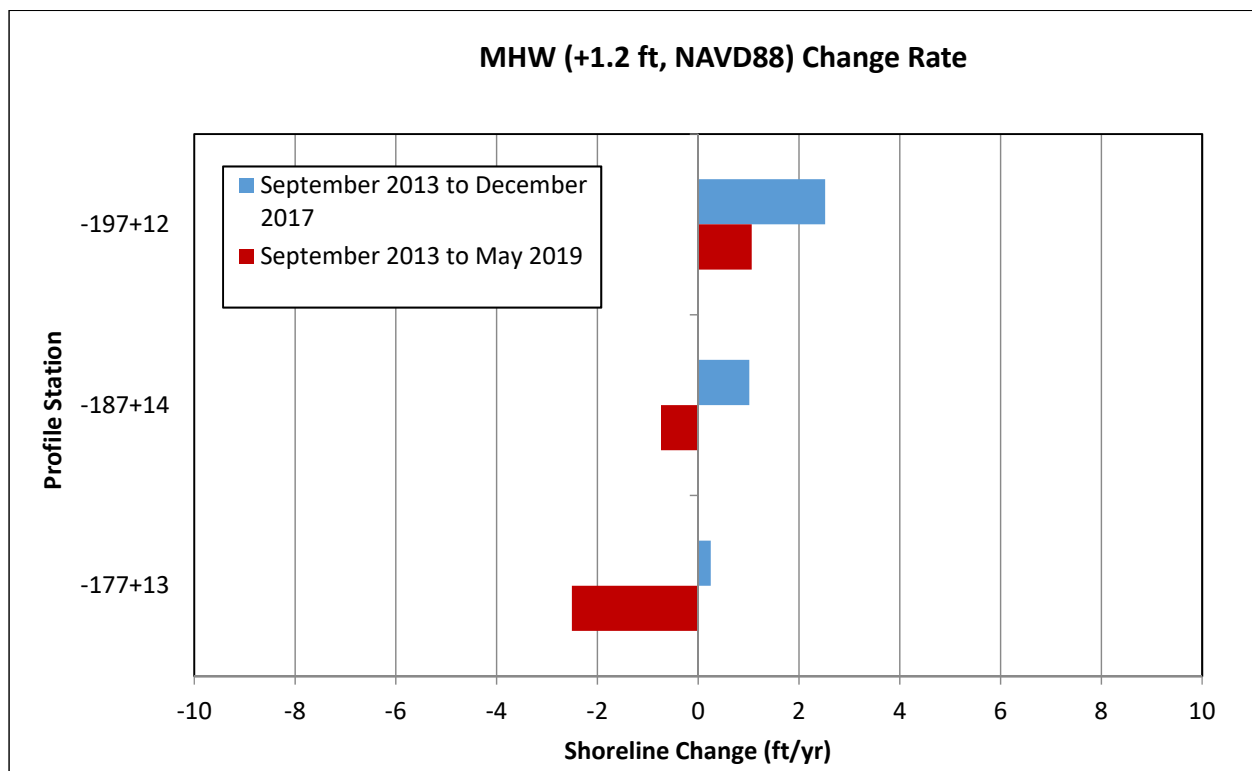
**Figure 5. Average shoreline change rates measured from October 2006 to December 2017, and from October 2006 to May 2019.**

The position of the MHW shoreline measured in May 2019 along the northern 2,000 feet of Southern Shores (Stations -197+12 to -177+13), was compared to the position of the MHW shoreline measured during a survey conducted in September 2013 for the Town of Duck. An average MHW shoreline change of -4.1 ft. was measured over the approximately 5.7-year period. This equates to an average MHW shoreline change rate of -0.7 ft./yr. This negative shoreline change rate is a reversal in the trend of positive shoreline change measured between September 2013 and December 2017 (+1.3 ft./yr.). Figure 5 shows the MHW shoreline change rate for each of the three northern profiles measured between September 2013 and December 2017 and between September 2013 and May 2019.

The reversal of the shoreline change trend measured along the northern 2,000-foot section of the Town's oceanfront between September 2013 and May 2019 was driven by higher negative shoreline changes measured between December 2017 and May 2019. During the 1.4 year period between December 2017 and May 2019, the average shoreline change rate measured along this section of beach was -6.7 ft./yr. Negative shoreline change rates (landward) were measured along each of the three beach profiles, ranging from -3.3 ft./yr. at Station -197+12 (northern Town Limit) to -10.8 ft./yr. at Station -177+13 (approximately 200 feet south of 9<sup>th</sup> Ave.)

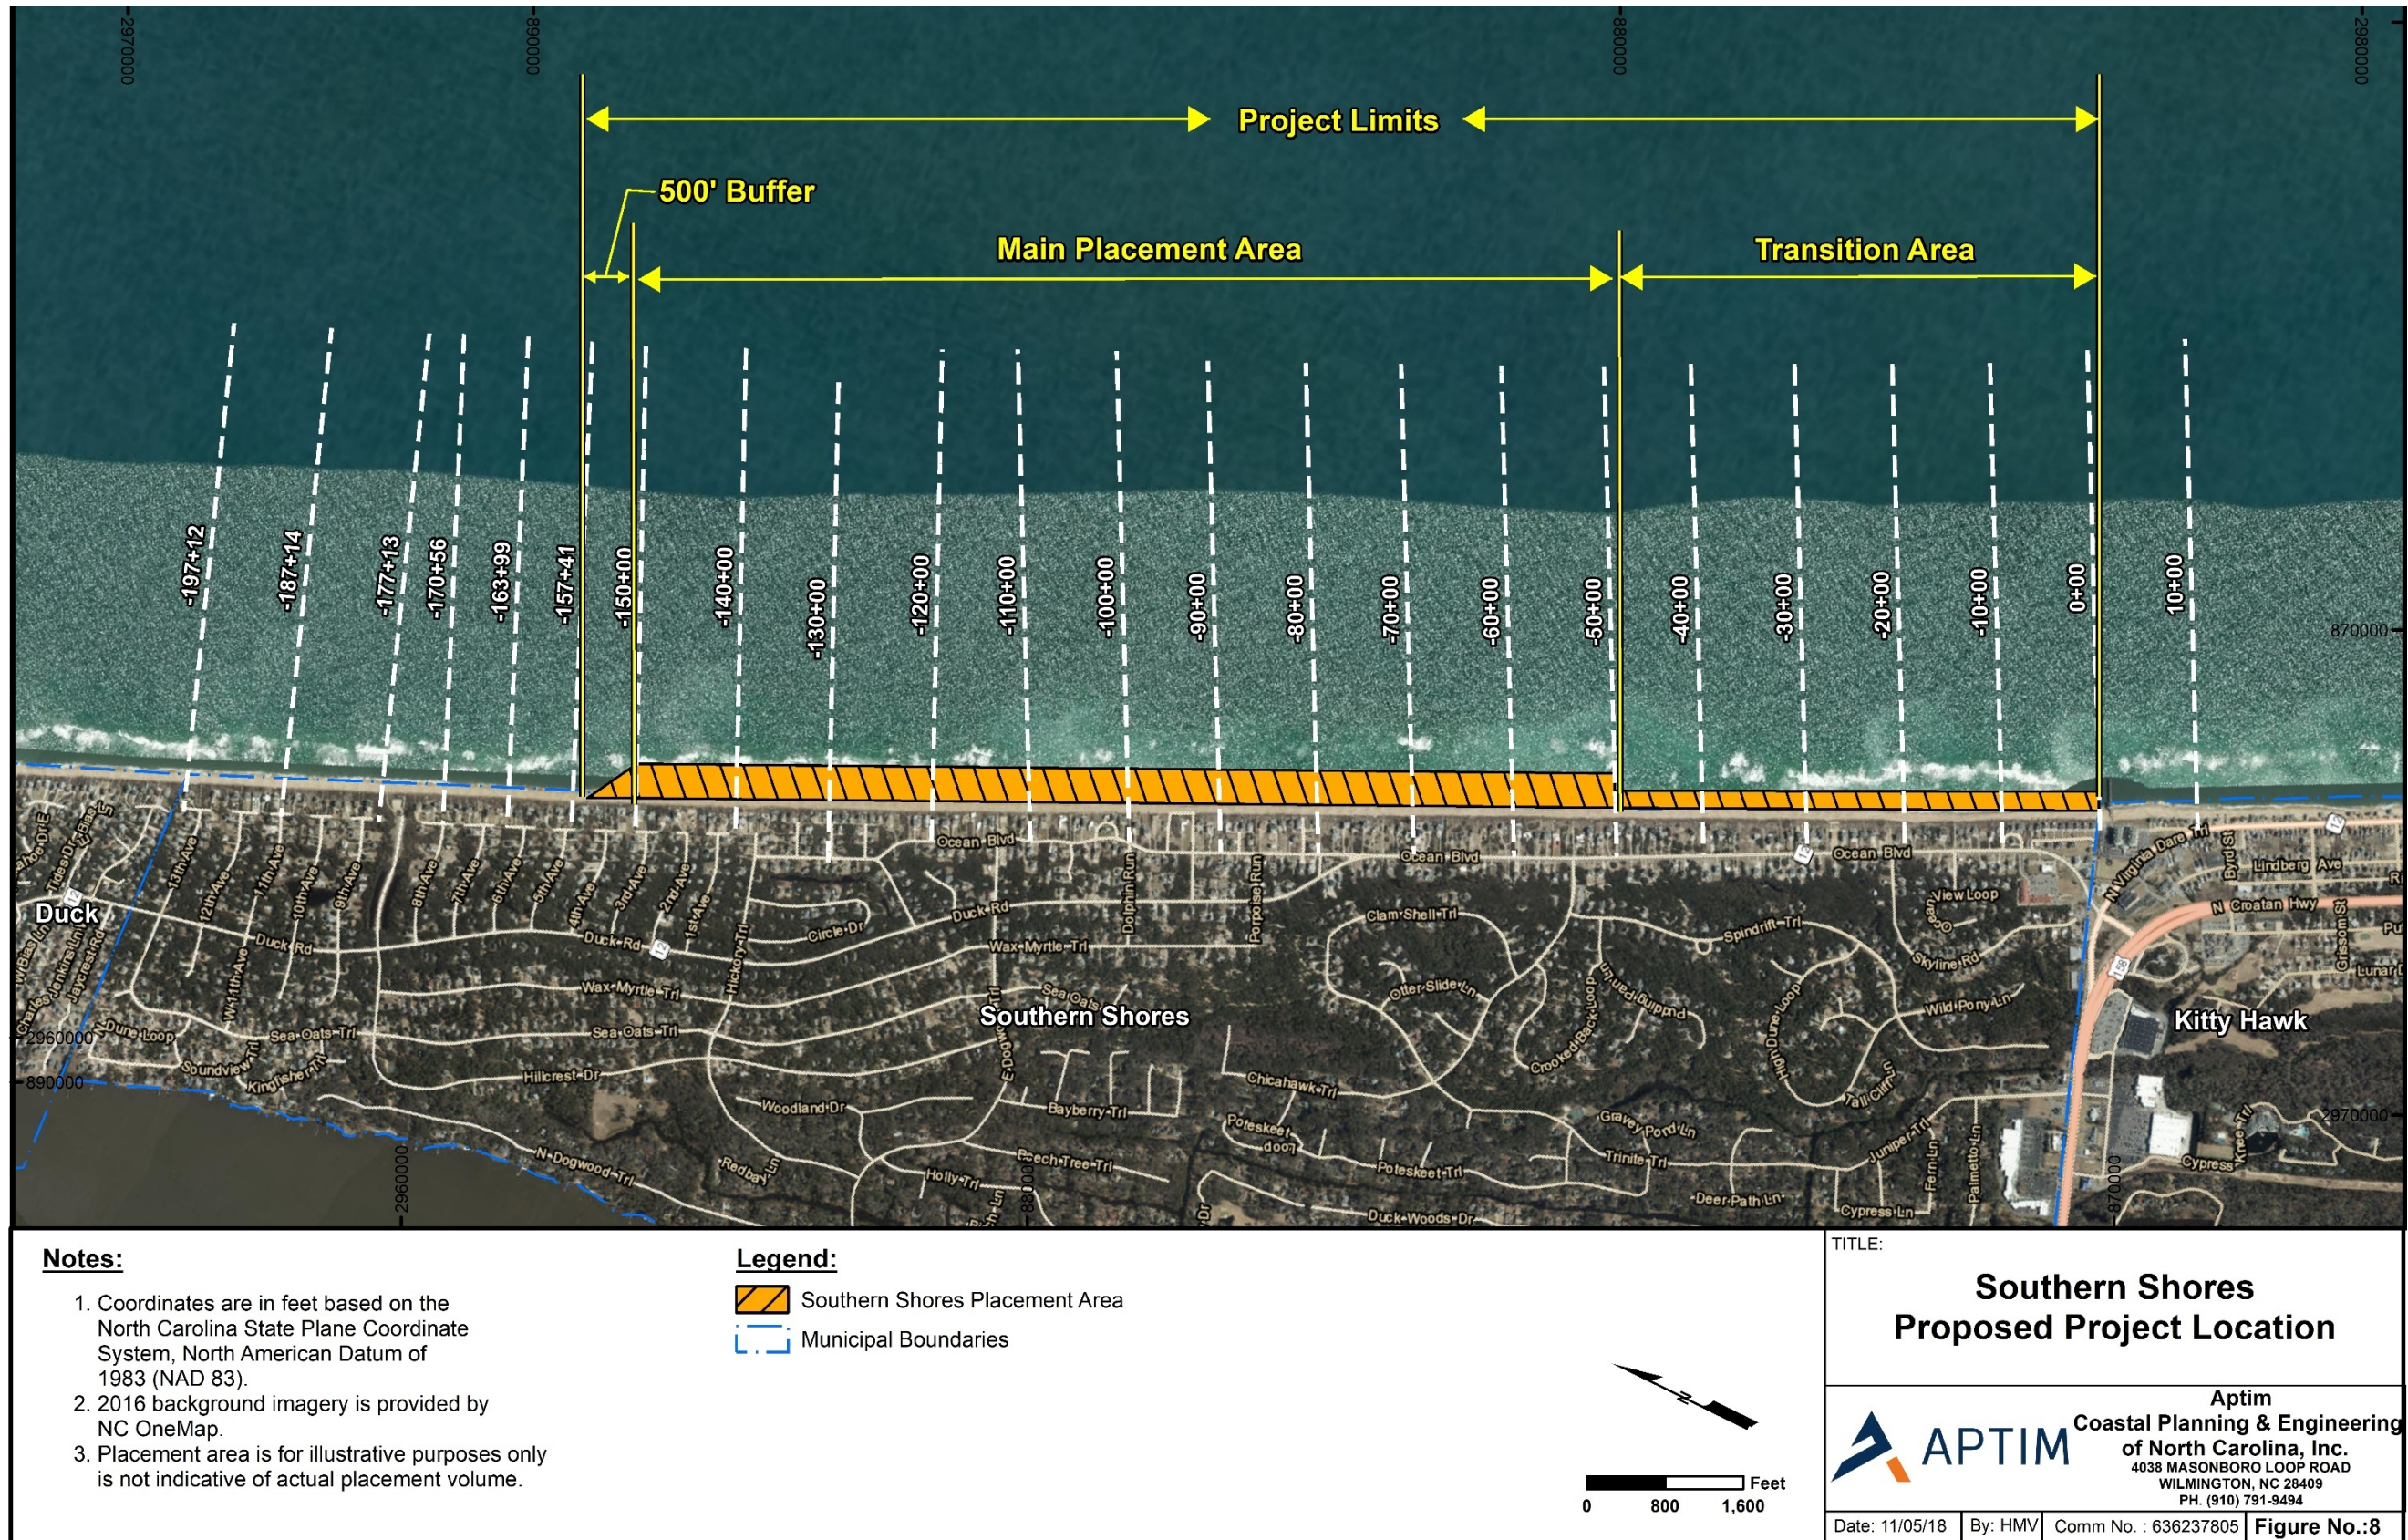
**Figure 7. Location Map showing the recommended project extent including the Main Placement Area and Transition Area.**

In the area referred to as the “Main Placement Area” in Figure 7 which extends from Station -150+00 south to Station -50+00, the average fill density measured inside the volume envelope falls below the targeted design volume for both Scenarios 3 and 11 by 38.6 cy/lf and 50.6 cy/lf, respectively. Despite an average increase of 6.6 cy/lf. in the density measured along this section of beach when compared to December 2017 conditions, this section of beach still warrants placement of beach fill based on the goal of designing to the Scenario 3 and Scenario 11 storms.

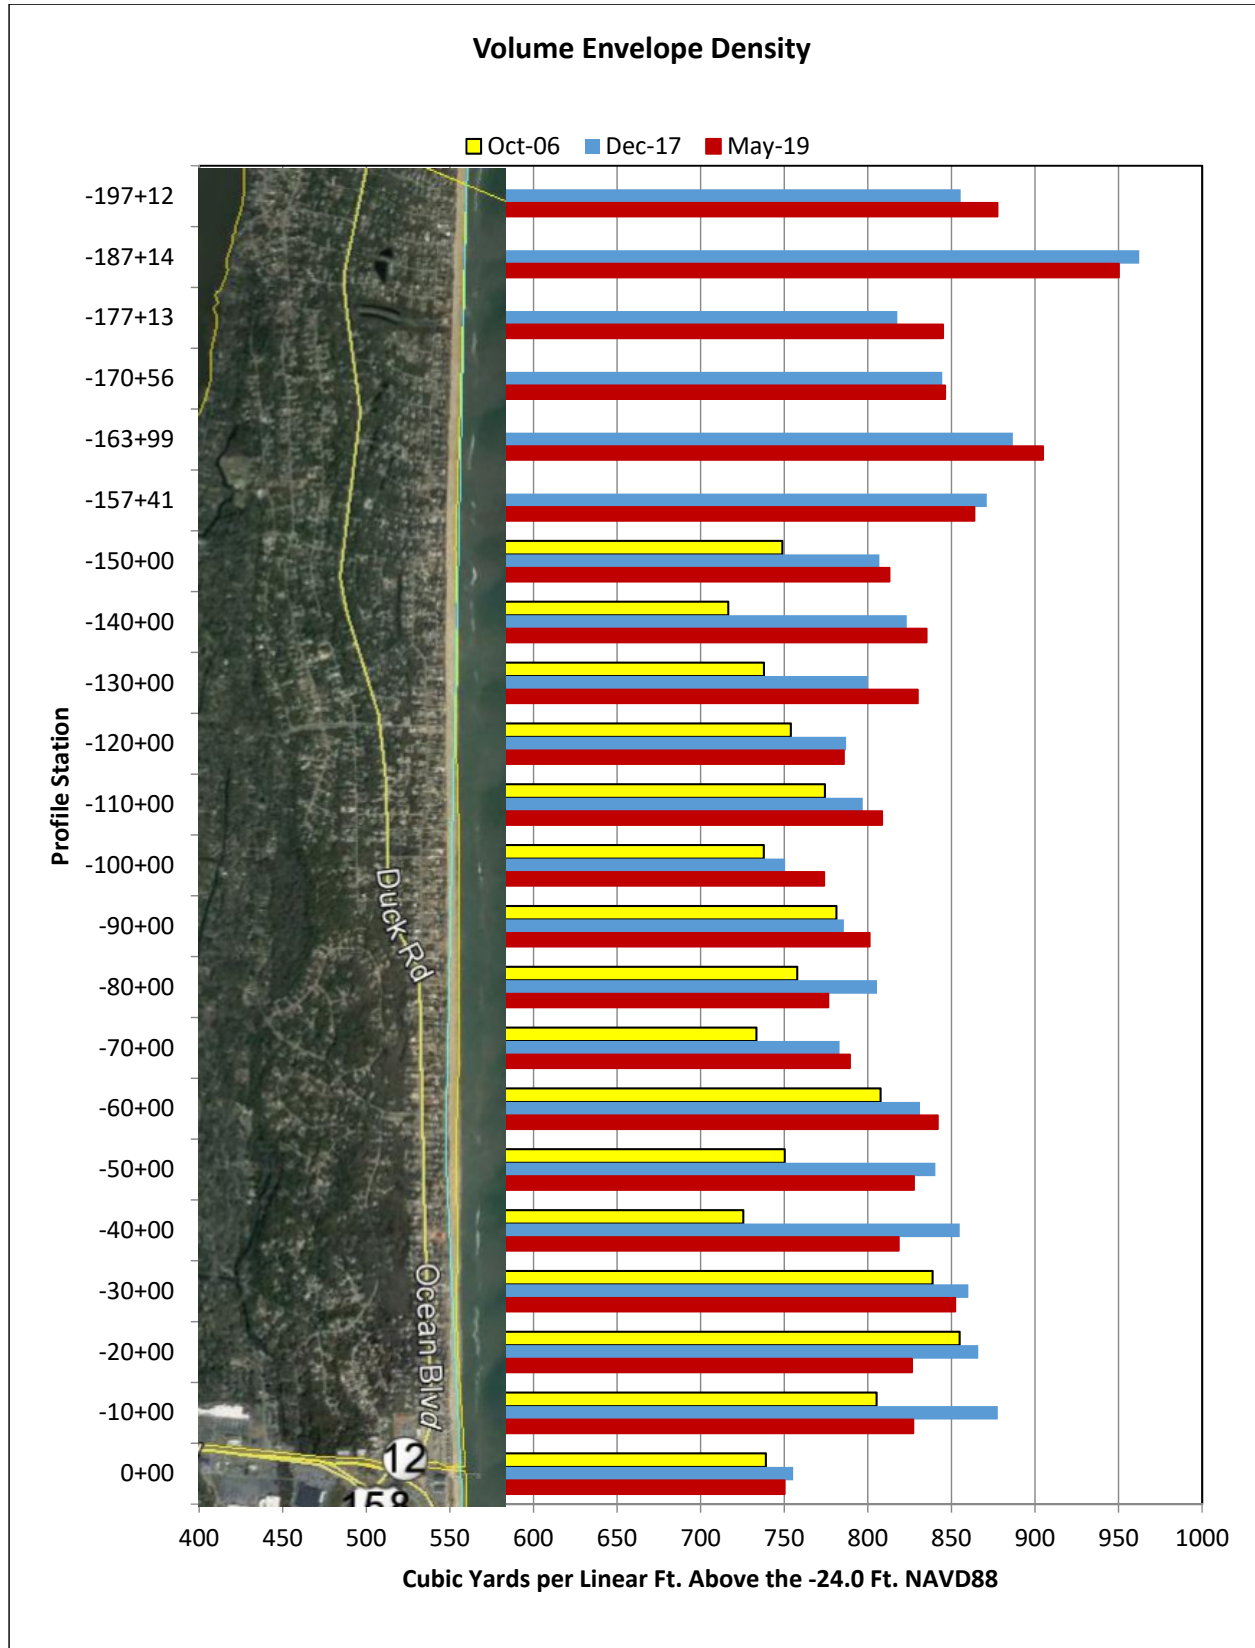
Figure 10 shows the volume measured within the volume envelope along each of the 22 Southern Shores profiles surveyed in December 2017 and May 2019. The average volume within the envelope measured along all 22 profiles in December 2017 was 830 cy/ft. and in May 2019 was 829 cy/lf. The volume envelope density is discussed in the subsequent sections in regards to evaluating the project extent and project volume.

Figure 10. Volume envelope calculations across all Southern Shores profiles.

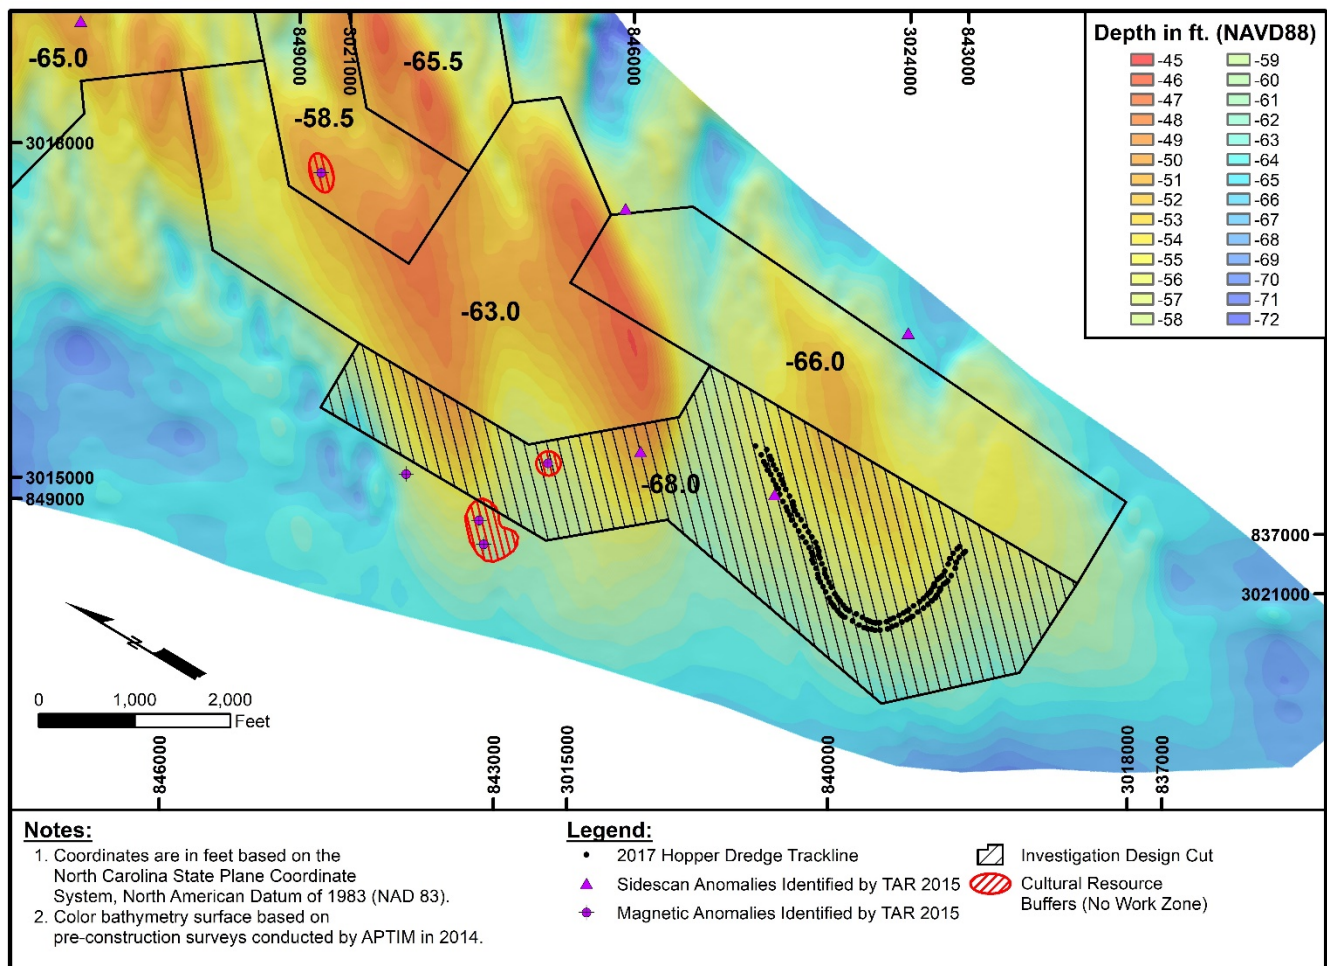
Figure 1: Map of Borrow Area A indicating the area excluded by the dredgers during the remaining portion of the 2017 project.
